CAFO FACILITY INSPECTION REPORT

Miersma Dairy No. 1
FACILITY NAME

03/05/2013
ACTUAL INSPECTION DATE

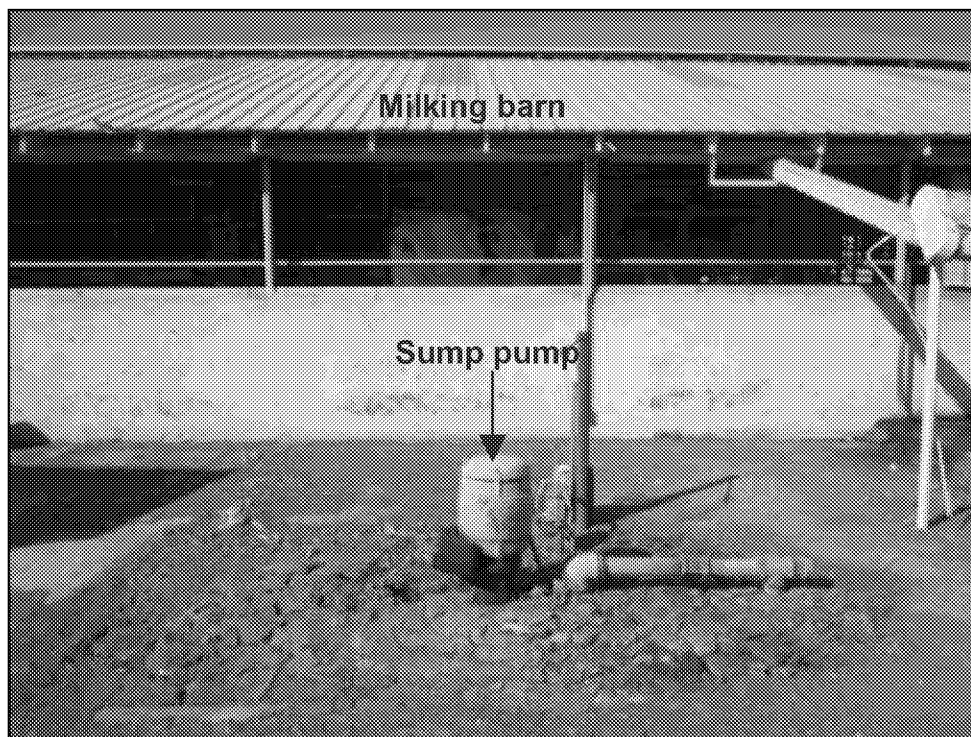
Photograph 2. View facing north of the process wastewater sump pump on the south side of the milking barn. The sump pump conveys process wastewater south to the catch basins where it is land applied via alfalfa valves.

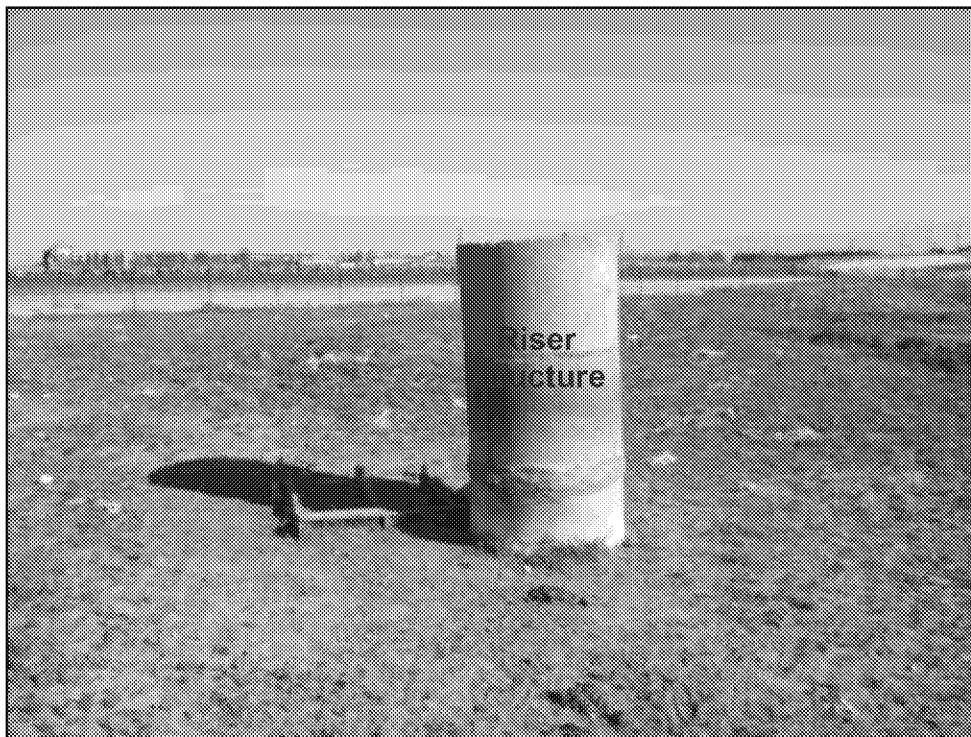
Photograph 3. View facing northeast of the process wastewater riser structure located northeast of the catch basins. The riser structure distributes wastewater to alfalfa valves located north of the catch basins.

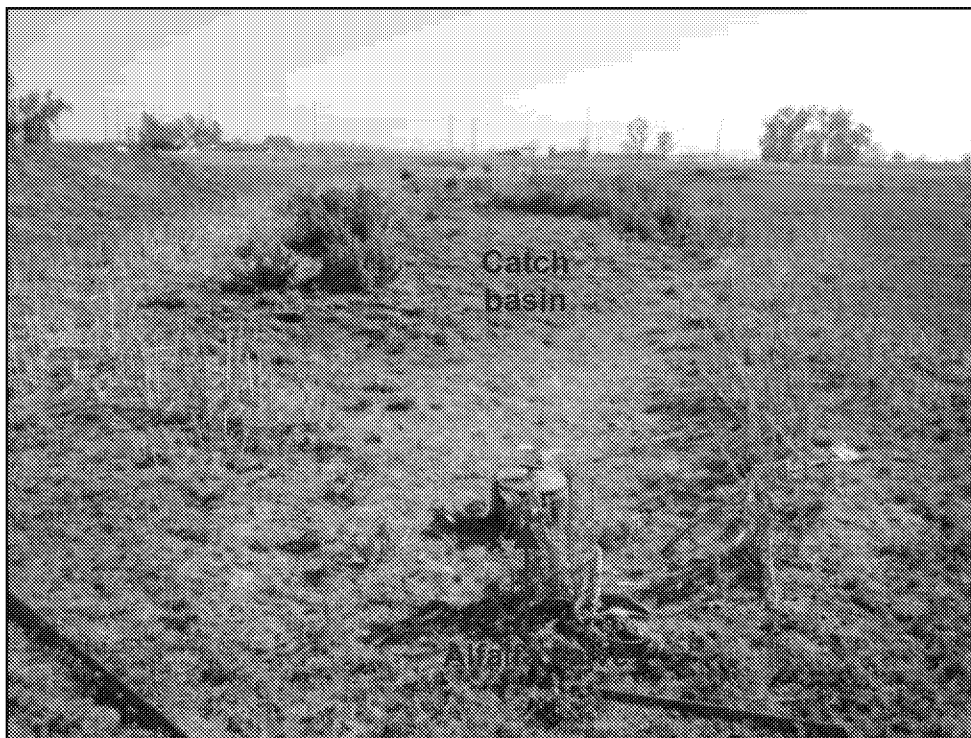
Photograph 4. View facing south of an alfalfa valve located on the north side of the catch basins. Note process wastewater flows from the alfalfa valves south into the catch basin, and eventually into the pasture located between the catch basins and containment pond in the southwest corner of the Facility.

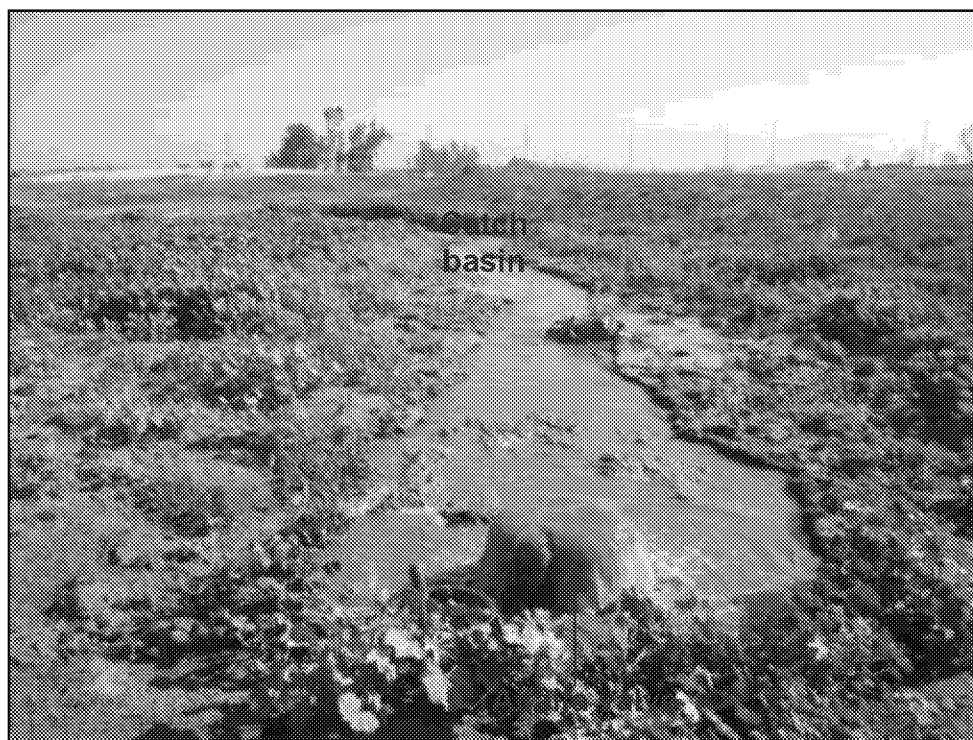
Photograph 5. View facing south of an alfalfa valve actively applying process wastewater to a catch basin.

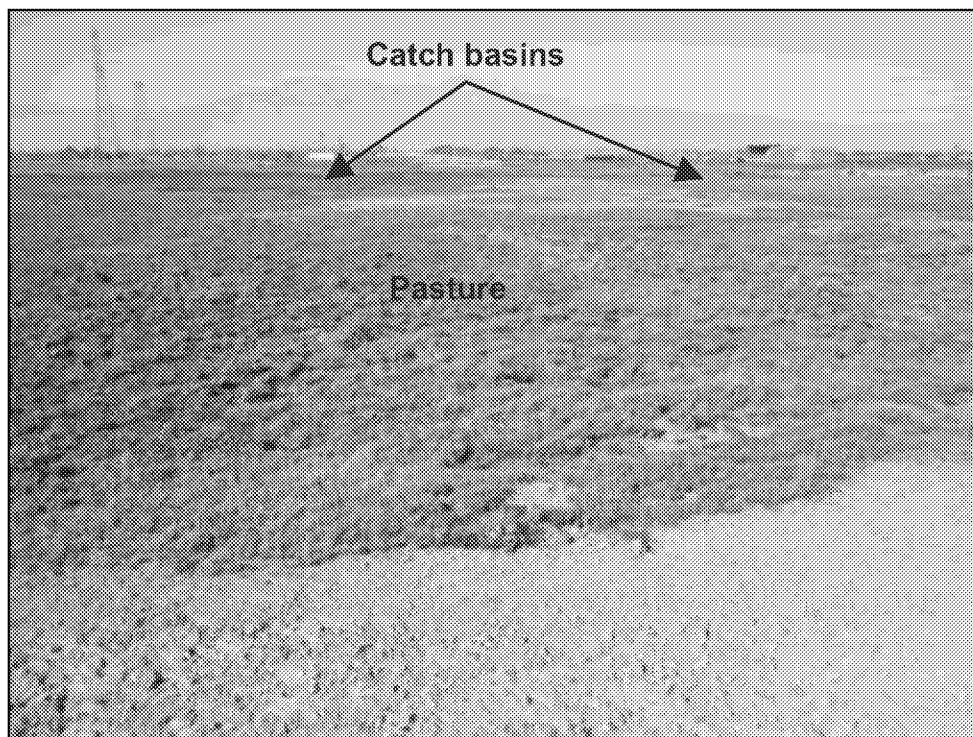
Photograph 6. View facing north from the north side of the existing pond in the southwest corner of the Facility at the pasture located between the existing pond and the catch basins.

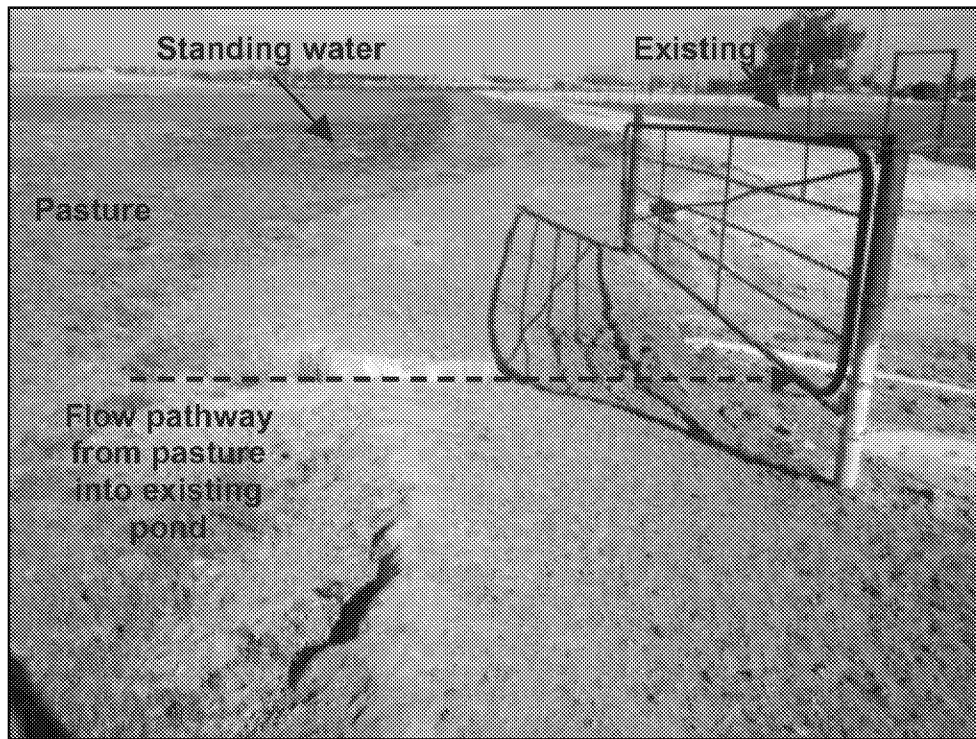
1. The EWMP was not fully implemented onsite at the Facility at the time of the inspection, as required by Provisions VII.C.3.a-b of the Permit (refer to Photos 7 and 8)

Photograph 7. View facing east of the flow pathway from the pasture south of the catch basins into the containment pond in the southwest corner of the Facility. Note the standing water in the pasture adjacent to the pond.

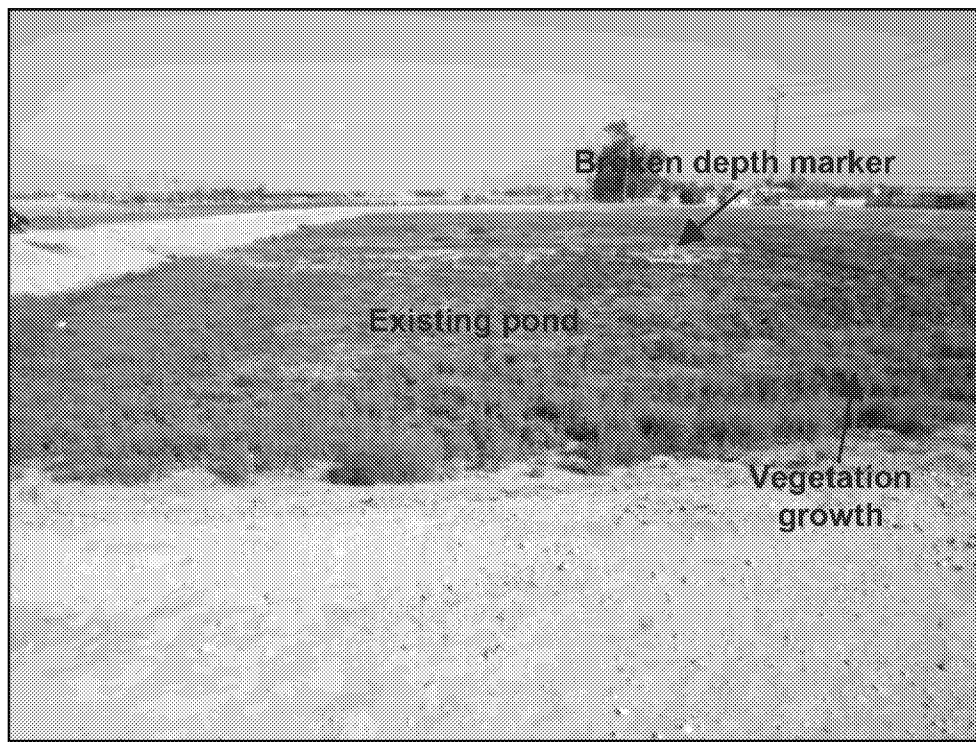
- A broken depth marker was observed in the existing pond in the southwest corner of the Facility (refer to Photos 8 and 9)
- Weekly Storm Water Management Structure visual inspections for the 2013 Monitoring Year had not been conducted at the Facility since February 12, 2013 (refer to Exhibit 1)
- The Engineered Waste Management Plan (EWMP) was not fully implemented onsite at the Facility at the time of the inspection (refer to Photos 7 and 8)
- Vegetation growth was observed in the containment pond in the southwest corner of the Facility (refer to Photo 8)

1. The inspectors observed, during the inspection, a broken depth marker in the existing pond in the southwest corner of the Facility at the time of the inspection (refer to Photos 8 and 9). The broken depth marker was identified during a weekly inspection on January 15, 2013 (refer to Exhibit 1). Permit Attachment B - Monitoring

and Reporting Program, Section I.B.2 states that "deficiencies not corrected within 30 days shall be accompanied by an explanation of the factors preventing immediate correction." Mr. Miersma stated that a replacement depth marker was located onsite at the Facility; however, he had not yet made time to install it.

1. The EWMP was not fully implemented onsite at the Facility and the containment structures were not adequately maintained as required by the Permit. Item No. 7 of the 'Operation and Maintenance' section of the EWMP states that "the dairy operator shall maintain weed control on the top and inside of the pond embankments...excessive growth of any vegetation will be controlled with mowing and/or grazing." Vegetation growth was observed inside

the containment pond located in the southwest corner of the Facility (refer to Photo 8). It should be noted that Mr. Miersma stated that the bottom of the containment pond in the southwest corner of the Facility is plowed annually. As a result of the observed vegetative growth, the Discharger had not adequately maintained the containment structure to ensure capacity and was not fully implementing the approved EWMP. The Discharger shall design, construct, and maintain containment structures and shall fully implement the EWMP as required by Provisions VII.C.3.a and VII.C.3.b of the Permit.

1. The inspectors observed, during the inspection, that vegetation growth potentially affecting the containment structure capacity was present in the containment pond located in the southwest corner of the Facility (refer to Photo 8). This item is addressed in Item No. 1 of the 'Engineered Waste Management Plan Review' section of this report. Provisions VII.C.3.a of the Permit states that "the discharger shall design, construct, and maintain containment structures to retain all wastewater within the facility, including all process wastewater and all precipitation on, and drainage through, manured areas resulting from rainfall up to and including a 25-year, 24-hour rainfall event." The Discharger must design and maintain all containment structures per the EWMP as required by Provisions VII.C.3.a-b of the Permit.

Photograph 8. View facing east of the existing pond in the southwest corner of the Facility. Note the broken depth marker and vegetation growth in the pond bottom.

1. Verify whether or not a new depth marker has been installed in the existing pond located in the southwest corner of the Facility
2. Ensure that Weekly Storm Water Management Structure visual inspections are being conducted at the Facility as required by the Permit and approved EWMP
3. Verify if the EWMP has been fully implemented onsite at the Facility

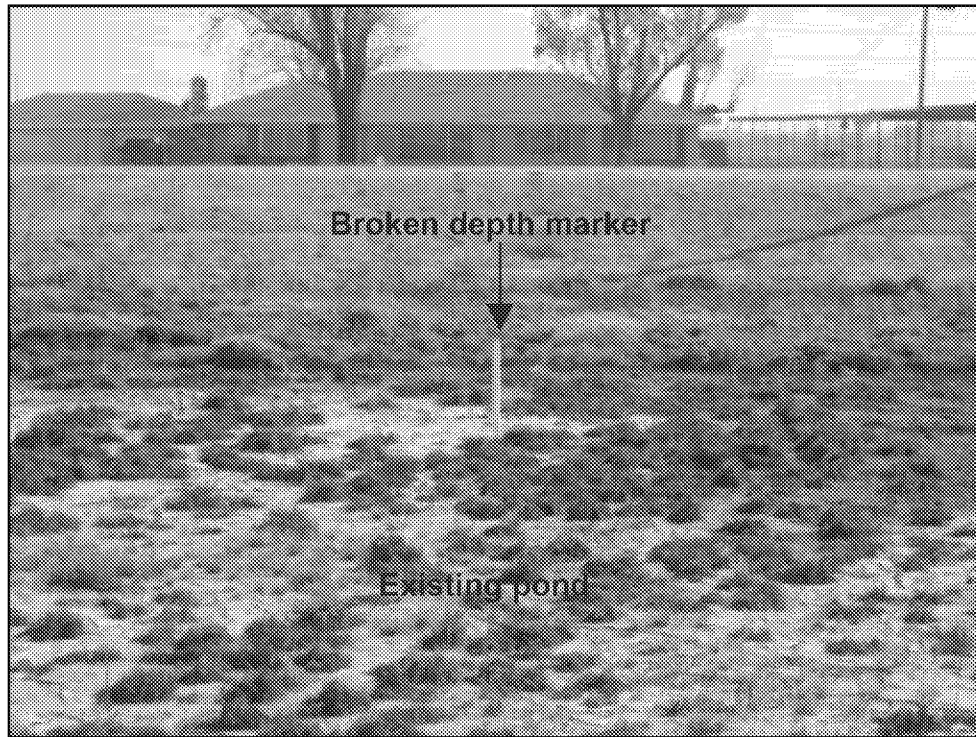
Photograph 9. Close-up view of the broken depth marker in the existing pond located in the southwest corner of the Facility, shown in Photograph 8.

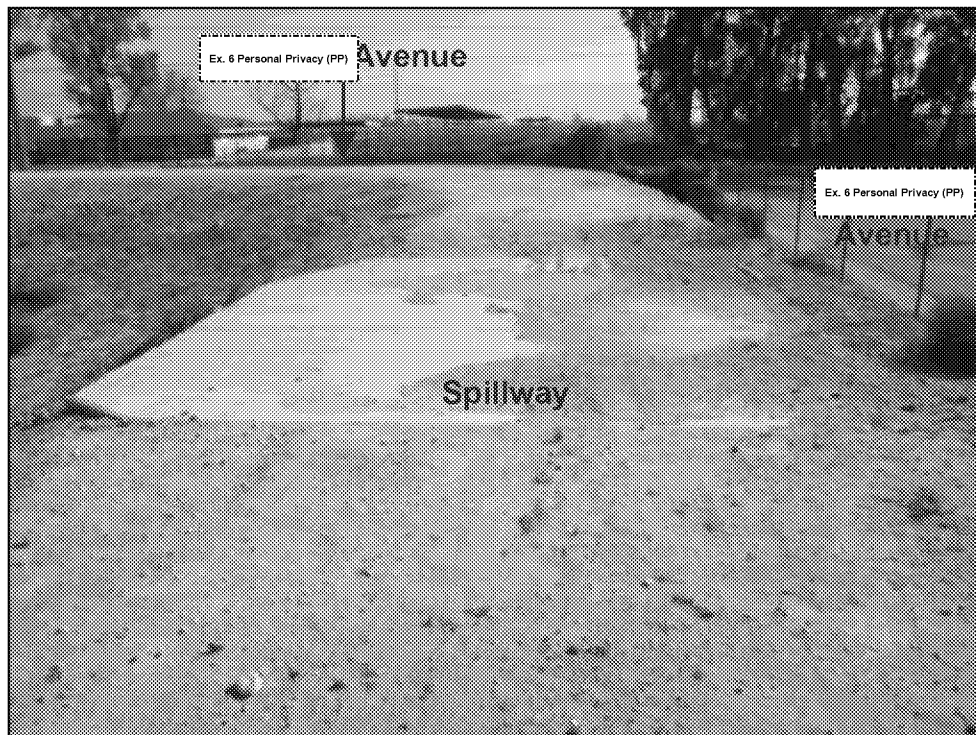
Photograph 10. View facing south of the concrete spillway located in the southwest corner of the existing pond, shown in Photographs 8 and 9, adjacent to Ex. 6 Personal Privacy (PP) Avenue and Ex. 6 Personal Privacy (PP) Avenue.

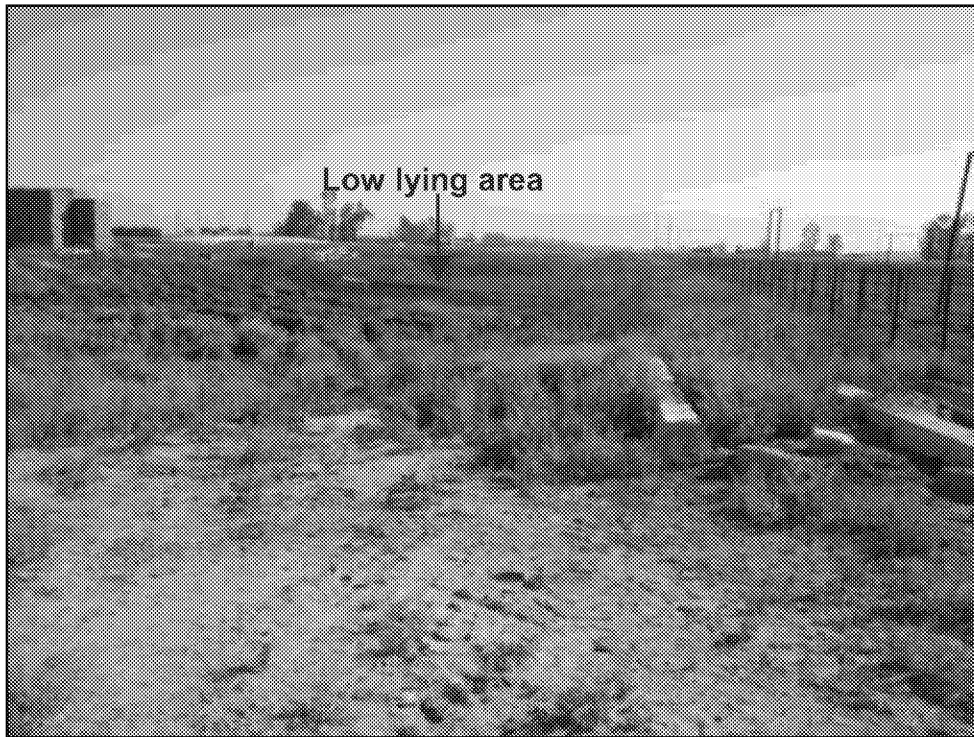
Photograph 11. View facing south of a low lying area in the central portion of the Facility. Surface runoff and storm water runoff from the corrals flows to this area and eventually into the catch basins.
